Indoor air quality (IAQ) in a naval ship after refit program: a time variation analysis

To cite this article: Maryam Zahaba *et al* 2022 *IOP Conf. Ser.: Earth Environ. Sci.* **1013** 012004

Maryam Zahaba¹, Nur Sarah Fatimah Tamsi¹, Sakinah Engliman², Amirul Faiz Kamaruddin^{2,3}, Noor Artika Hassan⁴ and Arman Ariffin⁵

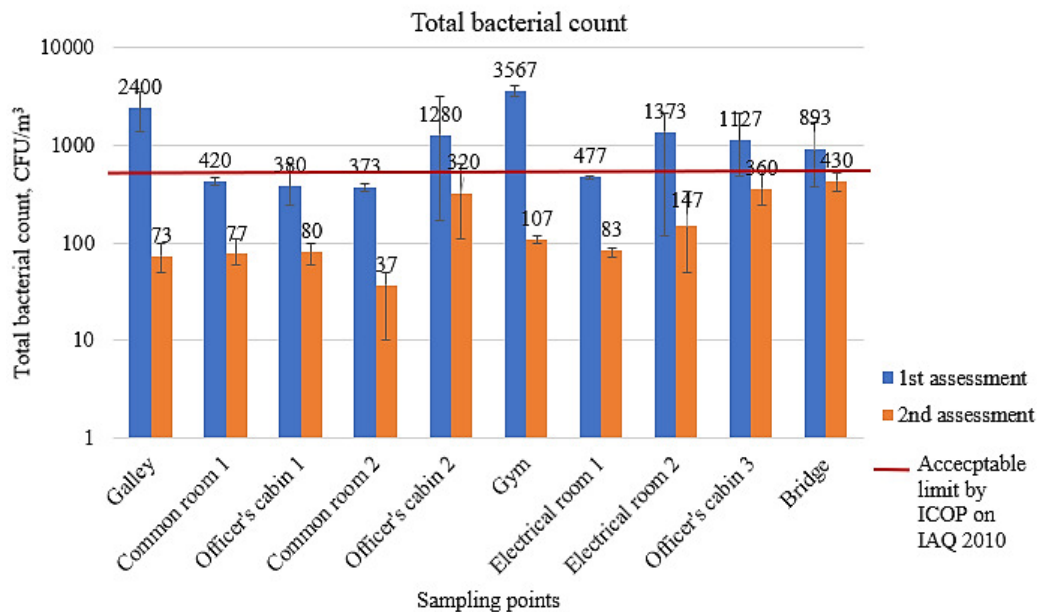
Most compartments reported a decrease in airborne bacterial and fungal count from the first phase assessment to the second assessment, except for fungal count in the bridge. Figures 2 and 3 show the different results for the bioaerosol count between the two phases and demonstrate the efficiency of the decontamination activity and the right setting of humidity controller on the HVAC system as practiced by the crew, by referring to the manufacturer's manual. The refurbishment activity during the refitting program had caused the resuspension of the microorganisms in the air and explained the exceeding CFU for the bacteria and fungi during the first assessment. Mousavi et al. (2020) found that renovation and refurbishment activities increase the resuspension of PM as well as microorganisms since PM can be a potential carrier for the microorganisms [18]. High CFU count of microbial is related to the high concentration of PM [19][20].

Figure 2. Total bacterial count during assessment phases

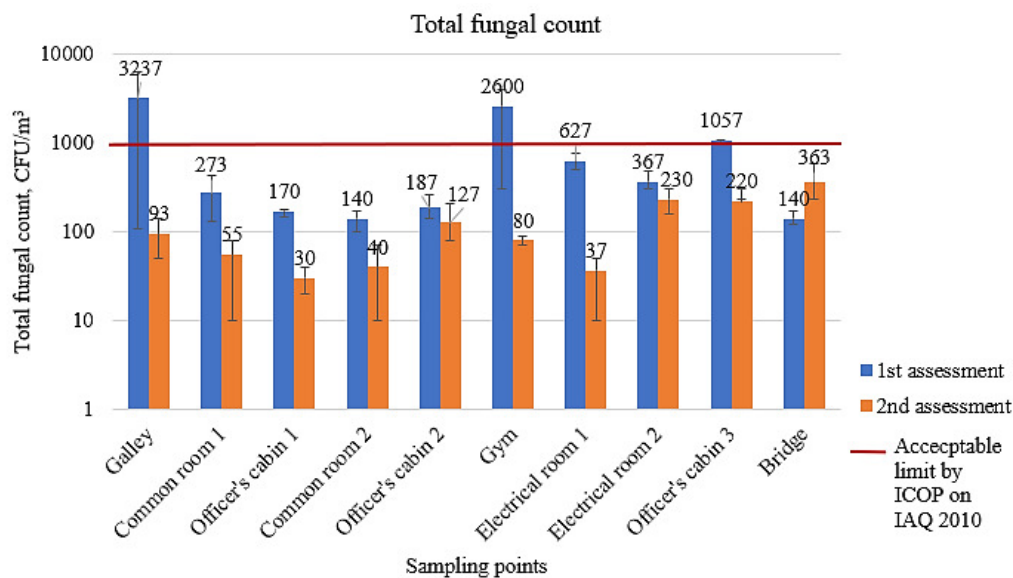
Figure 3. Total fungal count during assessment phases
