Engineering Geological Assessment at Grandview Heights, Paya Terubong, Pulau Pinang, Malaysia

Abstract. Grandview Heights, Paya Terubong is an old apartment building situated on a coarse-grained biotite granitic bedrock hillside. Paya Terubong is a landslide prone area where various landslides have been reported since 1998. The granitic hill has been disturbed during construction of the apartment. Due to the possibility of future landslides, an engineering geological study was conducted to assess the stability of this rock hill beneath this apartment. The scopes of study included discontinuity surveys, geomechanical characterization of the rock mass and slope stability analysis. Based on the results of discontinuity surveys, four major joints sets were identified and labelled as J1 (195°/62°), J2 (248°/65°), J3 (304°/63°) and J4 (230°/39°). One (1) potential planar failure J2 (248°/65°) and one (1) potential wedge failure J1-J2 intersection (213°/60°) were identified based on kinematic analysis. Dry rock density was from 2.56 g/cm³ to 2.61g/cm³. The water content was from 0.14 % to 0.15% with low porosity values from 0.50% to 0.54%. The point load strength index, $I_{s(50)}$ was 6

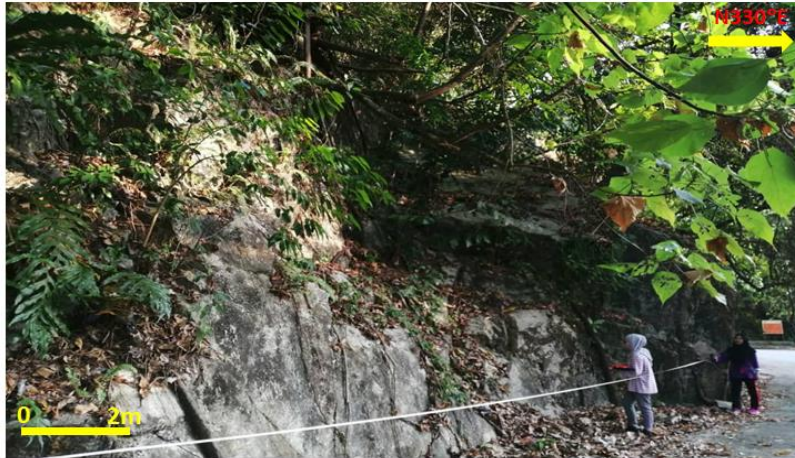
The slope (Figure 2) with the length of 80 m and height of 10 m is located at coordinates of $5^{\circ}22'19.0''N$ dan $100^{\circ}16'49.0''E$ (Figure 3). The granitic rock hill was disturbed during construction of the apartment. In view of possible future landslides an engineering geological study was conducted to assess the stability of the rock hill beneath this apartment.

Figure 2. The outcrop of study area is beneath Grandview Heights. The scanline method was conducted to quantify the discontinuities of the rock mass forming the slope.

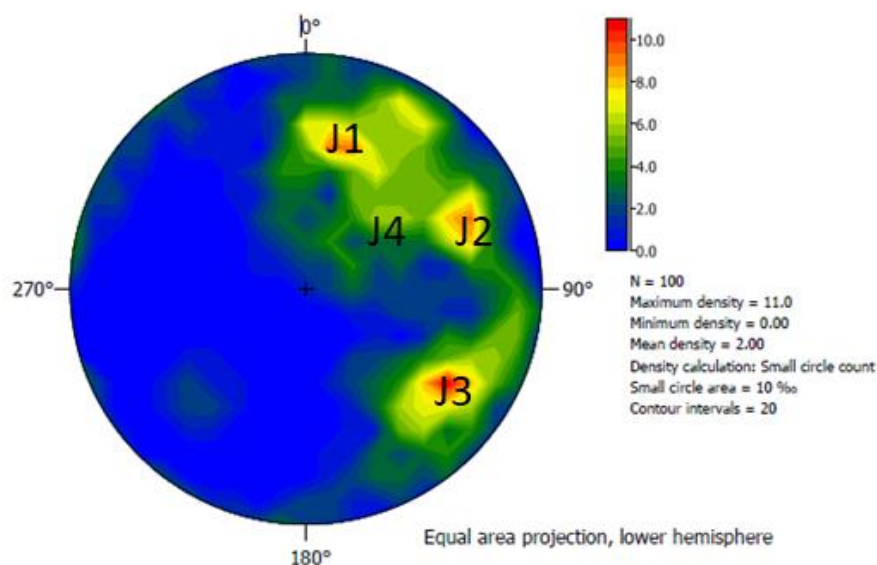
Discontinuities survey results revealed that the slope beneath Grandview Heights, Paya Terubong is composed of four sets of major joints (Figure 4) and labelled as J1, J2, J3 and J4. The dip direction and dip angle for J1, J2, J3 and J4 are $195^\circ/62^\circ$, $248^\circ/65^\circ$, $304^\circ/63^\circ$ and $230^\circ/39^\circ$ respectively. The 3D slope was produced by using photogrammetry method for geological interpretation. The joint set were identified and verified at field as shown in Figure 5. The results of slope kinematic analysis (Figure 6) showed the potential of one planar failure J2 ($248^\circ/65^\circ$) and one wedge failure J1-J2 ($213^\circ/60^\circ$). The orientation (dip direction/dip angle) of slope face is $240^\circ/65^\circ$. The peak friction angles (50°) for this slopes in kinematic analysis were determined based on the tilt testing method, suggested by [28] and [29].

Figure 4. Stereoplot for slope beneath Grandview Heights, Paya Terubong. Four sets of major joints were identified and labelled as J1 ($195^\circ/62^\circ$), J2 ($248^\circ/65^\circ$), J3 ($304^\circ/63^\circ$) and J4 ($230^\circ/39^\circ$).

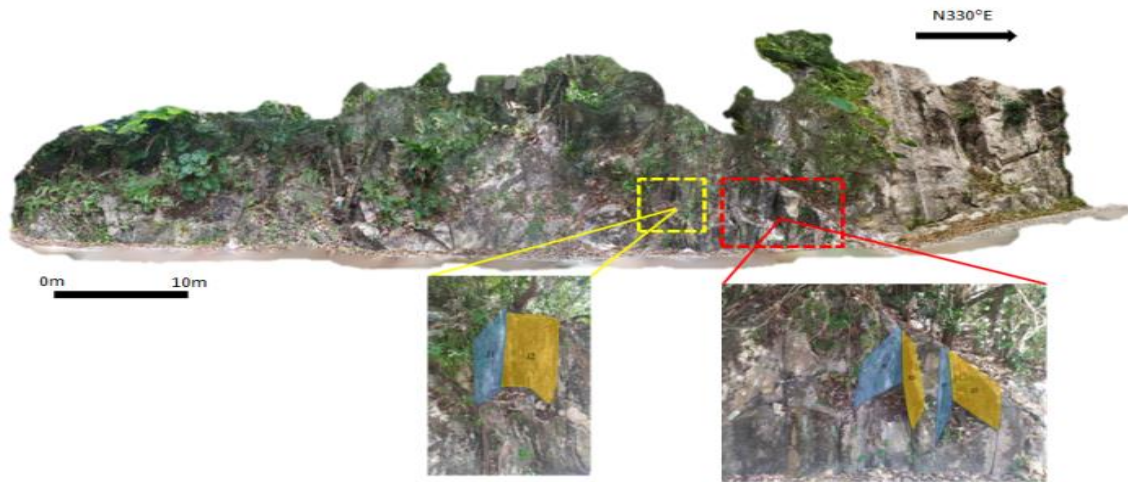
Figure 5. Joint sets J1 and J2 were verified at outcrop. The 3D slope was produced using photogrammetry method for better geological interpretation.

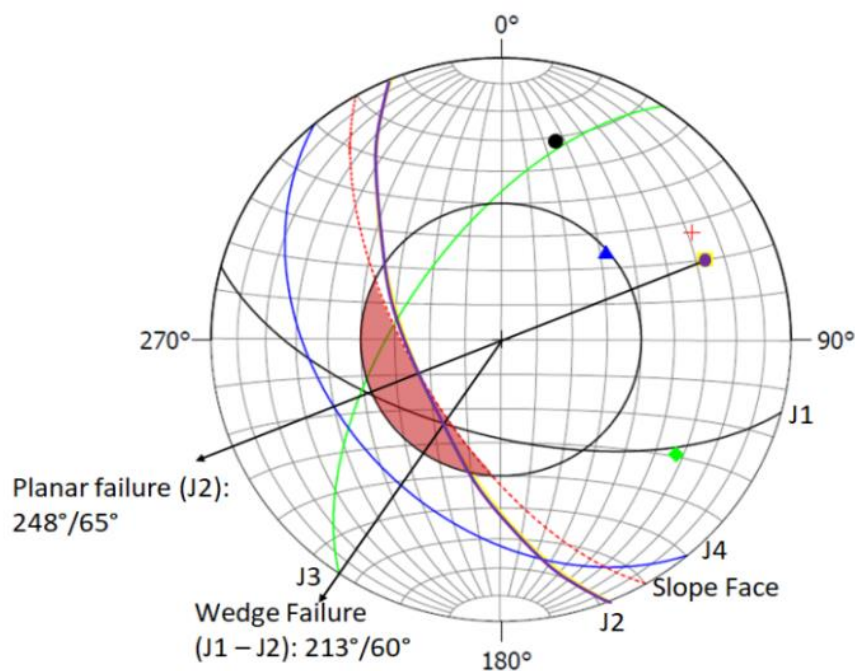
Table 1 and Table 2 show the result of assessment of RMR_{basic} and Slope Mass Rating. The rating of RMR_{basic} for this slope was 84. The respective SMR for potential planar J2 (248°/65°) and wedge failure J1-J2 (213°/60°) were 79 and 64 with class of II and probability failure of 0.2.

Figure 6. Kinematic analysis for slope beneath Grandview Heights, Paya Terubong. One potential planar failure J2 (248°/65°) and one potential wedge failure J1-J2 (213°/60°) were identified.

One potential planar failure J2 (248°/65°) and one potential wedge failure J1-J2 (213°/60°) were identified on the slope beneath Grandview Heights, Paya Terubong. The Slope Mass Rating for this slope was 64 to 79 and classified as class II. The engineering geological assessment revealed that this slope is stable with the probability of failure of 0.2.
