Mapping of post-event earthquake induced landslides in Sg. Mesilou using LiDAR

To cite this article: Habibah Hanan Mat Yusoff *et al* 2016 *IOP Conf. Ser.: Earth Environ. Sci.* **37** 012068

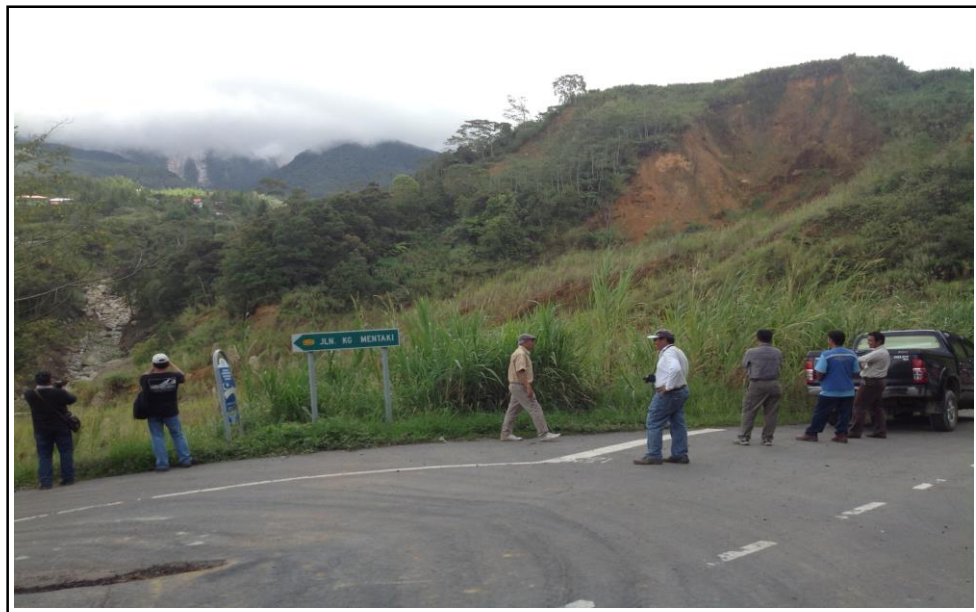
Figure 4. Field verification at Kampung Mesilou looking at landslides (see Figure 3b and 3d (right) and debris flow channel (left).

future. Thus, producing a landslide map of debris flow area is important to identify new, reactivated and historical landslides that were induced after the earthquake and debris flow event. About 70% of the interpreted landslides were verified in the field. The landslide boundary, type, activity and process are improved after getting input from local and expert knowledge and visualizing on the field as shown in Figure 4 and 5.

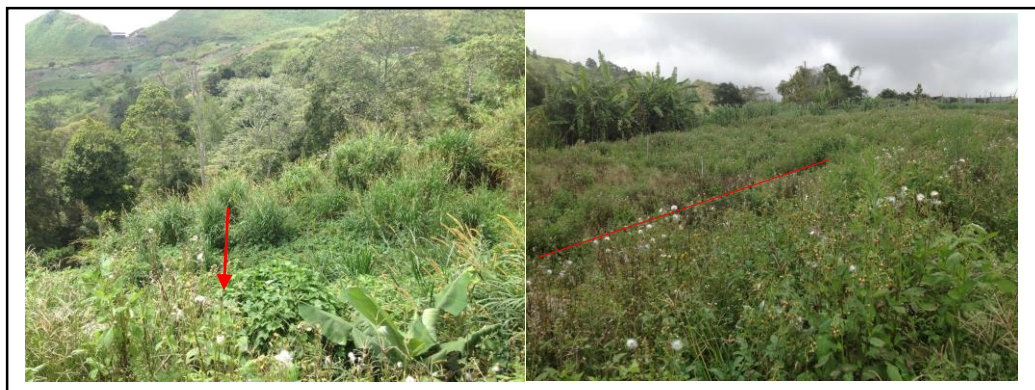
Figure 5. Field verification of a landslide (Figure 3c) indicating straight line of scarp by observing vegetation pattern and sudden drop of plantation area.

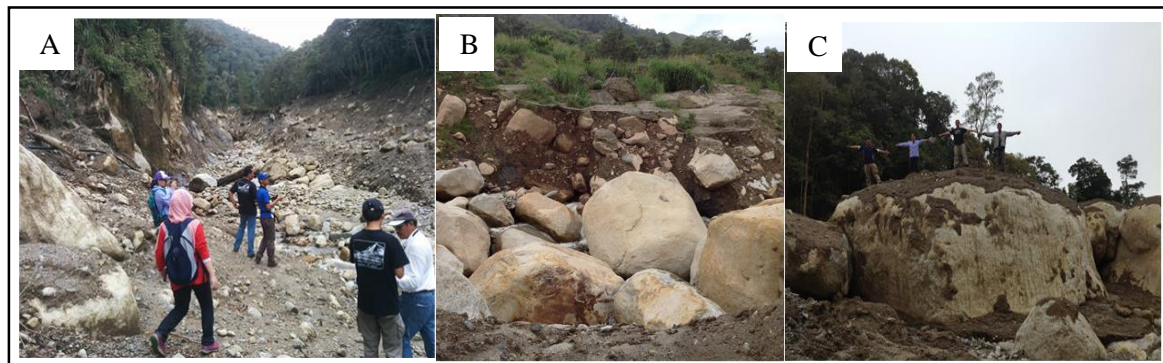
Figure 6. Debris flow observation at the source area (A), transport area (B), and deposition area (C).

A final landslide inventory is systematically stored in ArcGIS geodatabase system and overlaid with multi temporal satellite images to observe the land use changes and the impact of the disaster. Along the debris flow channel, five disconnected roads and bridges are observed and the event significantly stripped off the vegetation along the channel as shown in Figure 7. Another impact of landslides towards land use changes is landslides at Kampung Mesilou. Figure 8 shows images of before- and after the landslides event. The landslides damages the roads and plantation area and caused road to be re-routed. Multi temporal images reveal the important of landslide inventory using LiDAR for land-use planning to avoid future damages and monetary loss. In addition, landslide inventory also can generate landslide density map to identify the distribution and intensity of landslides. Based on Figure 9, the landslide has high density at the transport zone, low to medium density at source zone, and no density at deposition zone. This finding correlated with the understanding of river incision, which it usually highly incises the sediment at the transport zone and deposits the sediment at the deposition zone.

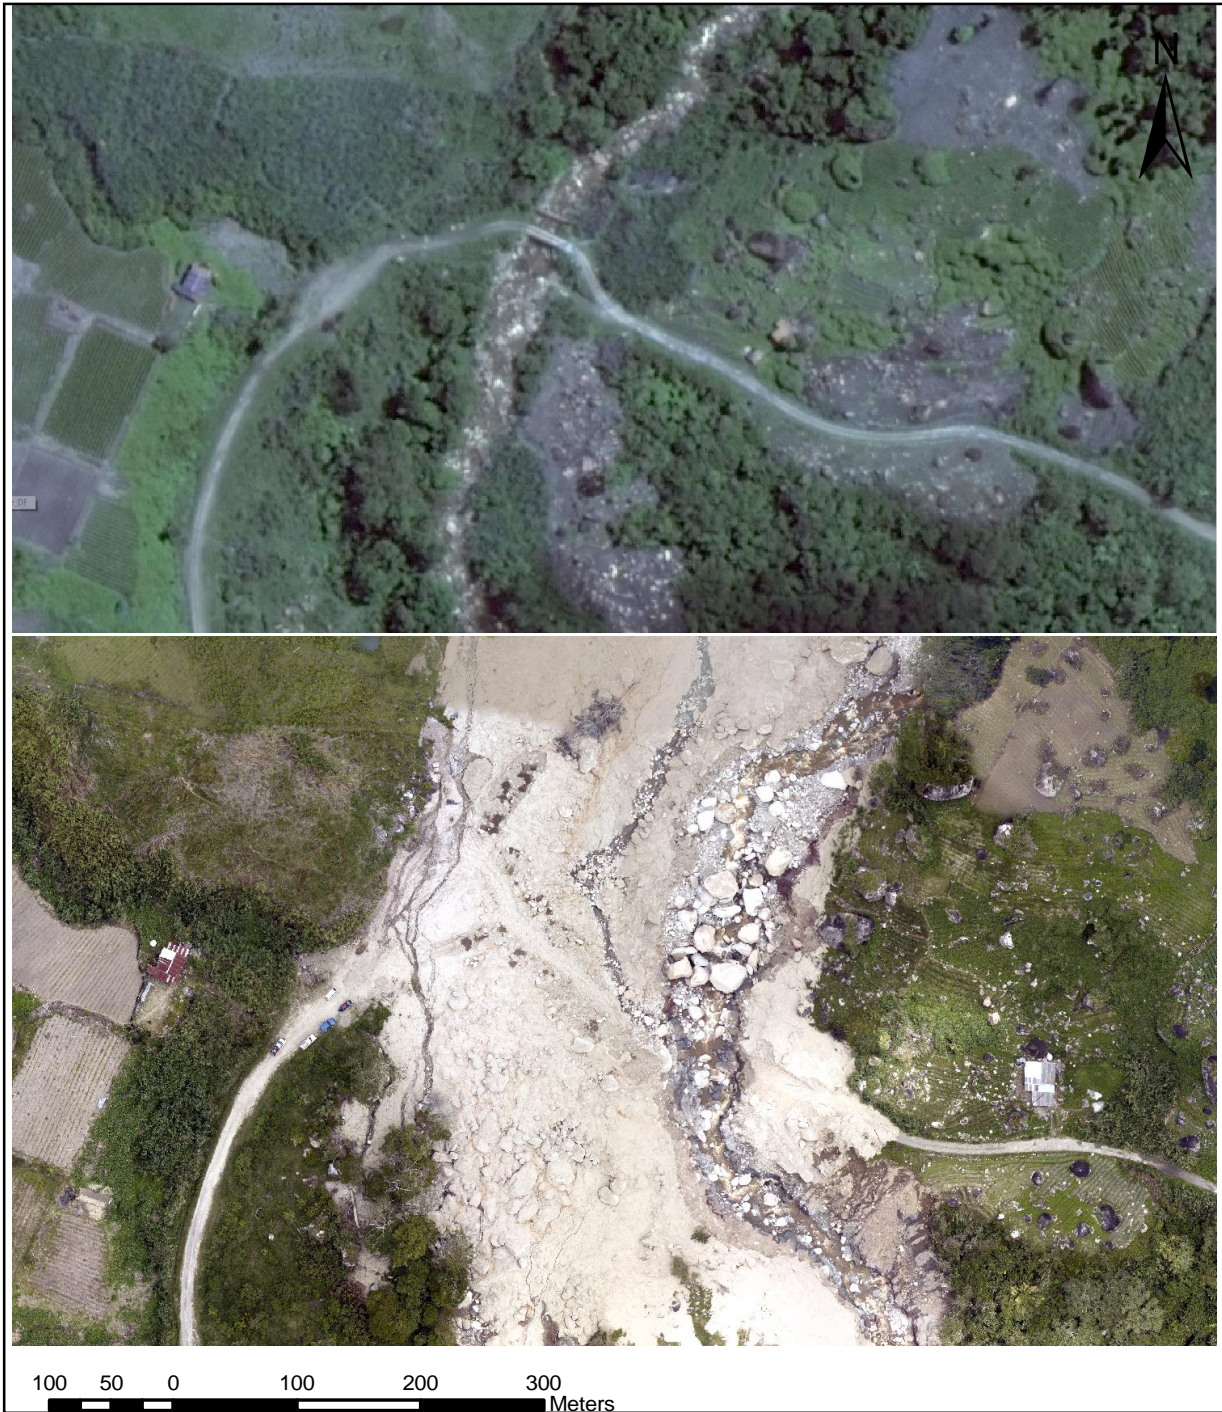
Figure 7. Multi temporal images disconnected roads before debris flow from Worldview image in 2011 (top) and after debris flow from orthophoto in 2015 (below). 5m of road was displaced after the debris flow event.

Another important analysis is analysing multi temporal landslide from satellite images before and after the debris flow. Worldview image in 2011 is acquired to compare with the orthophoto to observe the condition of the disconnected road before and after the disaster. SPOT image in 2010 also used to compare multi temporal landslides. The selected area is located in Kampung Mesilou, where the landslide occurred in March 2008, March 2010, and July 2013 [18]. These observation are important for land planners and engineers to identify element-at-risks before planning and construction.
