Application of Coastal Protection Structure for Mangrove Rehabilitation & Rejuvenation of West Coast Johor. Case Study: Tanjong Labuh, Batu Pahat, Johor.

To cite this article: Mohd Adib Mohammad Razi *et al* 2022 *IOP Conf. Ser.: Earth Environ. Sci.* **1022** 012064

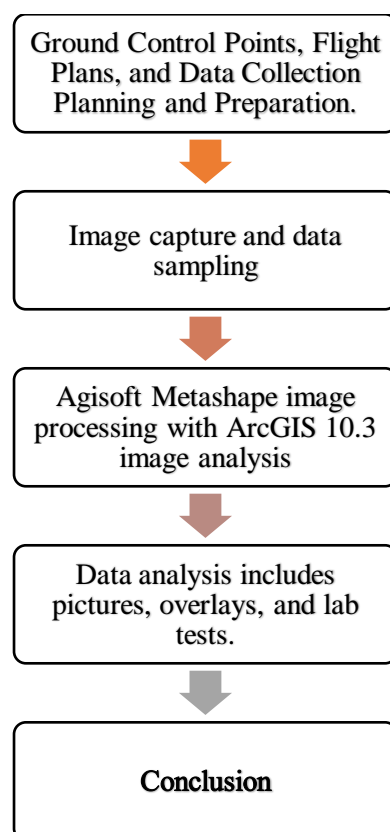
Figure 2. Flowchart of the study

The study's flowchart is shown in figure 2. The coastal region has followed the conventional approach to control and inspection activities as a matter of principle. As a result, UAVs were used in this study to complete the work in a cost-effective and efficient manner.

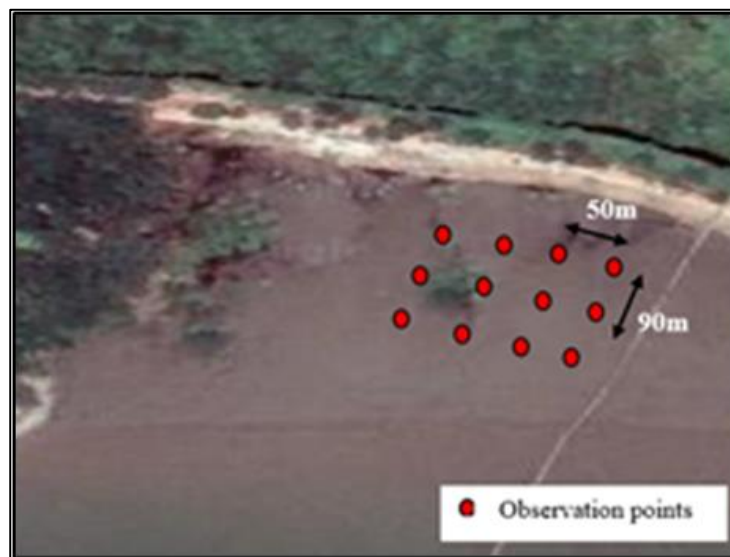
Figure 3. Observation points from the top view

Fieldwork for this study includes observing the height of coastal slope, measuring the depth of the beach, and collecting sediment samples in the study area. Observations of data for soil type or sediment will be taken to determine the size of the sediment found in the observation area. The method of using peat sampler is by immersing the body of peat sampler into the bottom of the beach and then turn the tool clockwise until a sediment sample is collected into the body of the tool. The sediment samples that have been taken next will be put in plastic bags that already have their respective labels and take it to geotechnical laboratory. Observational works such as sieve analysis test, specific gravity tests, and hydrometer tests have been carried out over a period. All observational data were recorded for the use of data analysis. The data observation process was done on 11 April 2021 during the low tide to facilitate the process of sediment sampling. Figure 3 shows the observation points on the actual map in Tanjung Laboh.

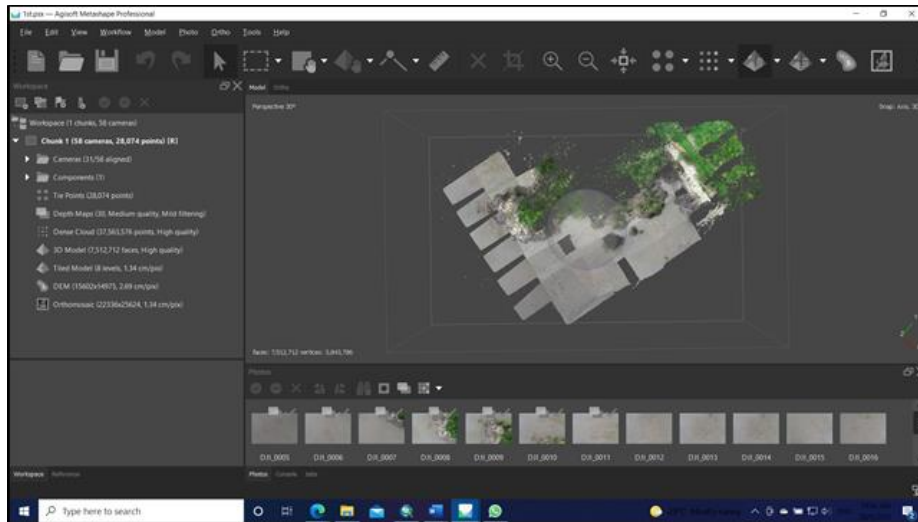
Figure 4. Image combined process to generated orthophoto in Agisoft Metashape

and 60% for side overlap. This is to ensure that high-resolution and accurate 3D images can be generated. Figure 4 illustrates the process of combining images to make an orthophoto in Agisoft Metashape.
