Engineering Geological Assessment at Grandview Heights, Paya Terubong, Pulau Pinang, Malaysia

Abstract. Grandview Heights, Paya Terubong is an old apartment building situated on a coarse-grained biotite granitic bedrock hillside. Paya Terubong is a landslide prone area where various landslides have been reported since 1998. The granitic hill has been disturbed during construction of the apartment. Due to the possibility of future landslides, an engineering geological study was conducted to assess the stability of this rock hill beneath this apartment. The scopes of study included discontinuity surveys, geomechanical characterization of the rock mass and slope stability analysis. Based on the results of discontinuity surveys, four major joints sets were identified and labelled as J1 (195°/62°), J2 (248°/65°), J3 (304°/63°) and J4 (230°/39°). One (1) potential planar failure J2 (248°/65°) and one (1) potential wedge failure J1-J2 intersection (213°/60°) were identified based on kinematic analysis. Dry rock density was from 2.56 g/cm³ to 2.61g/cm³. The water content was from 0.14 % to 0.15% with low porosity values from 0.50% to 0.54%. The point load strength index, $I_{s(50)}$ was 6

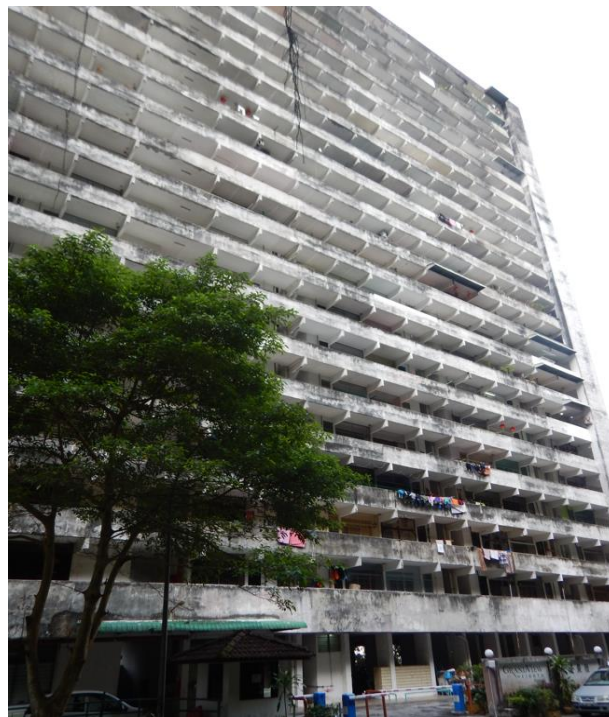
Grandview Heights, (Figure 1), Paya Terubong is an old apartment building situated on a coarse-grained biotite granitic bedrock hillside and is located in the south eastern part of the state of Penang. Paya Terubong is a landslide prone area where various landslides have been reported in this area since 1998.

Figure 1. Grandview Heights, Paya Terubong, Pulau Pinang
